RECONNAISSANCE PRESERVATION ASSESSMENT FOR MEMORY HILL CEMETERY, CITY OF MILLEDGEVILLE, GEORGIA

Chicora Research Contribution 445

Prepared By:
Michael Trinkley, Ph.D.

May 31, 2006

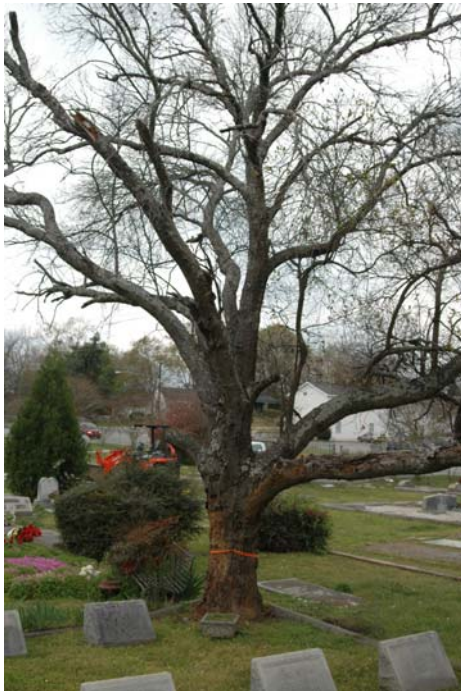
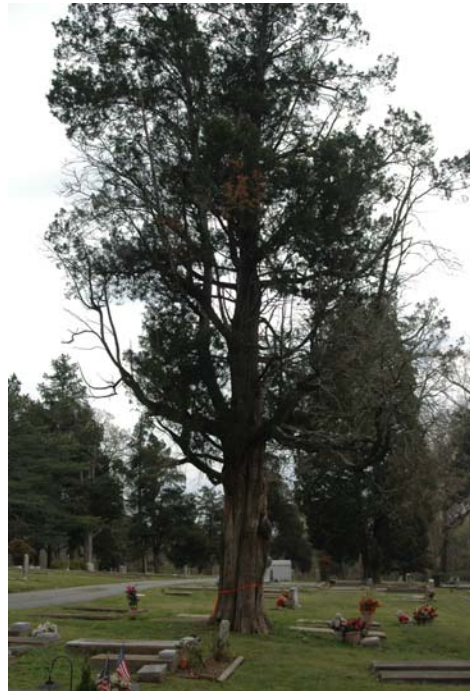
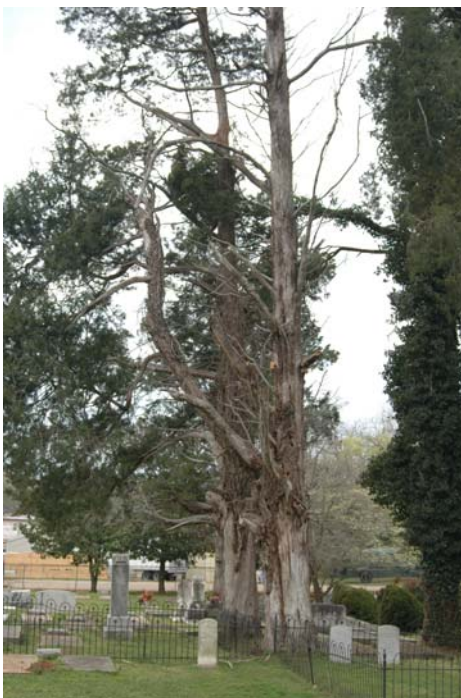
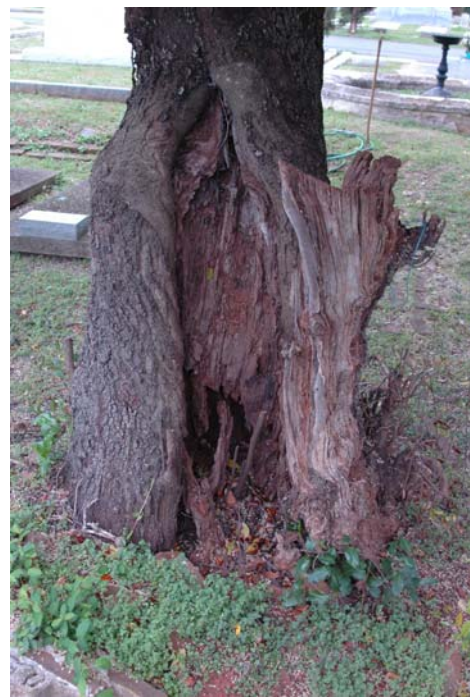
Figure 25. Common tree problems at Memory Hill. The photographs illustrate a few of the large number of dead and dying trees in the Cemetery. These trees present significant hazards for both the monuments and also those visiting the cemetery. Unfortunately, they represent some of the largest and most historic of the trees. Identical, large caliper trees should be replanted.

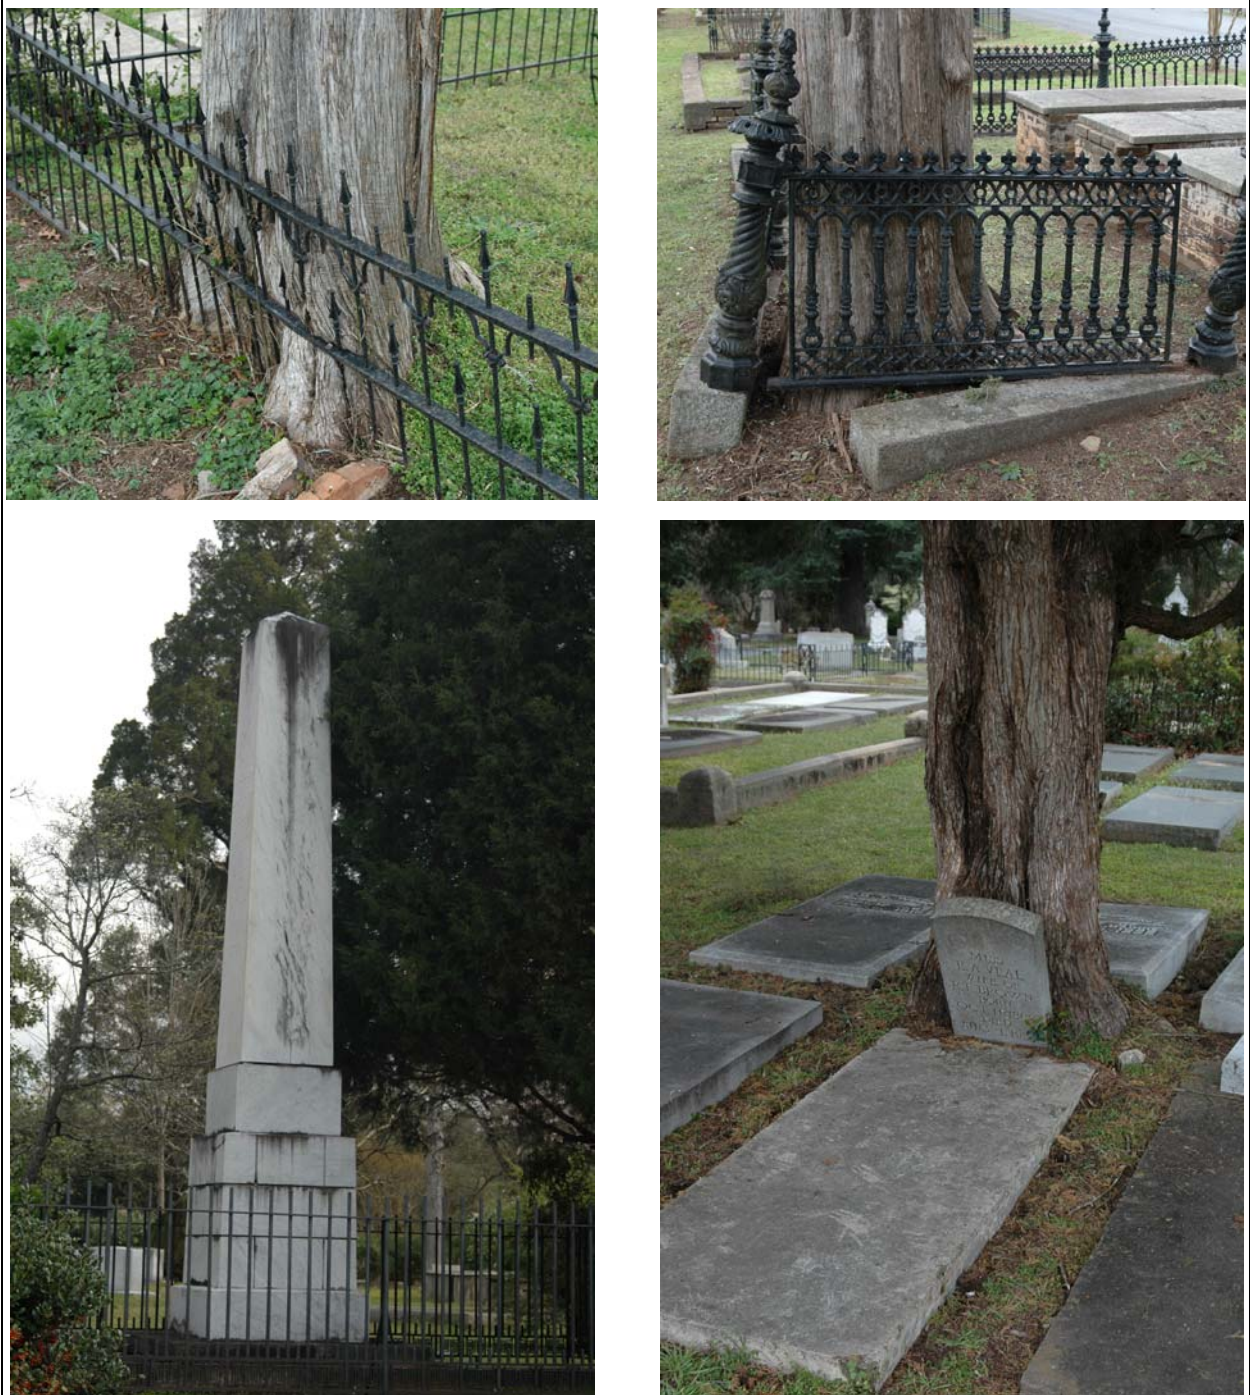
Figure 27. Tree and monument conflicts that require decisions to remove the vegetation, relocating the monument or fence, or prune the vegetation to reduce its impact.

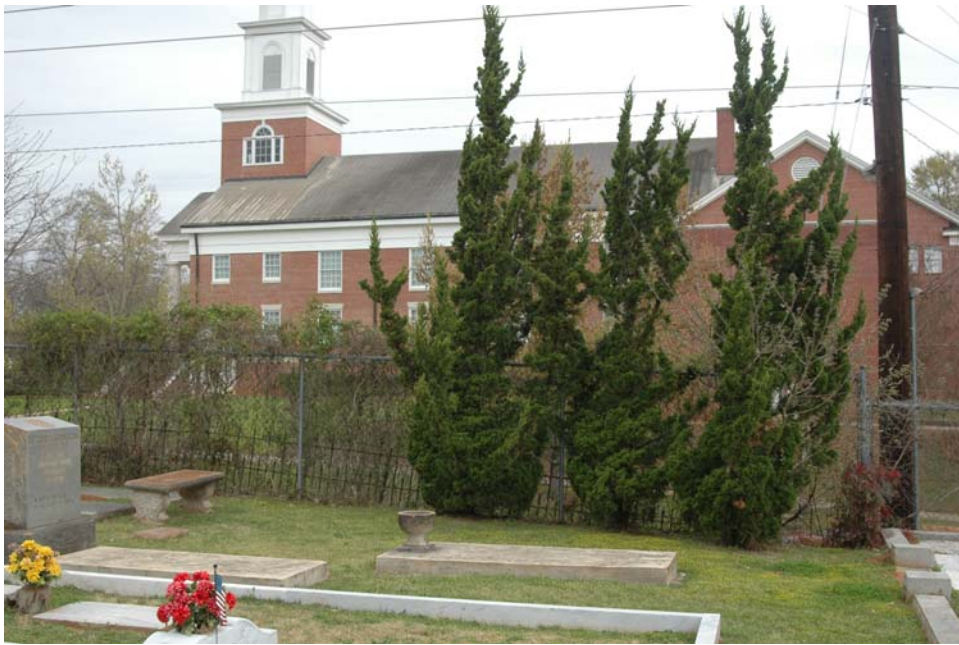
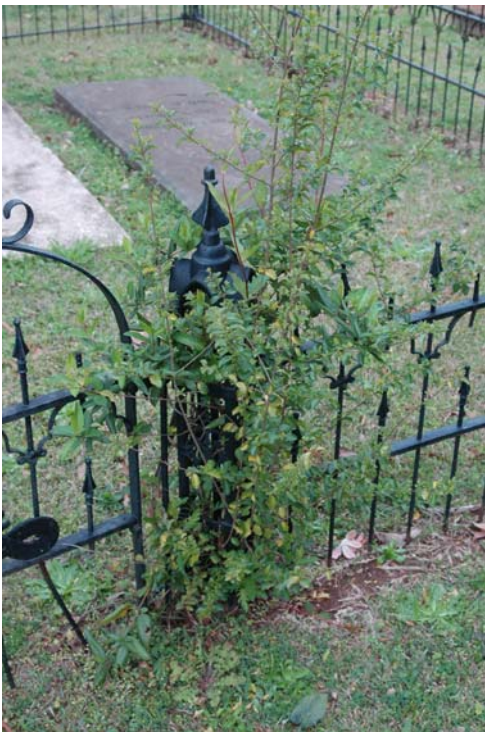
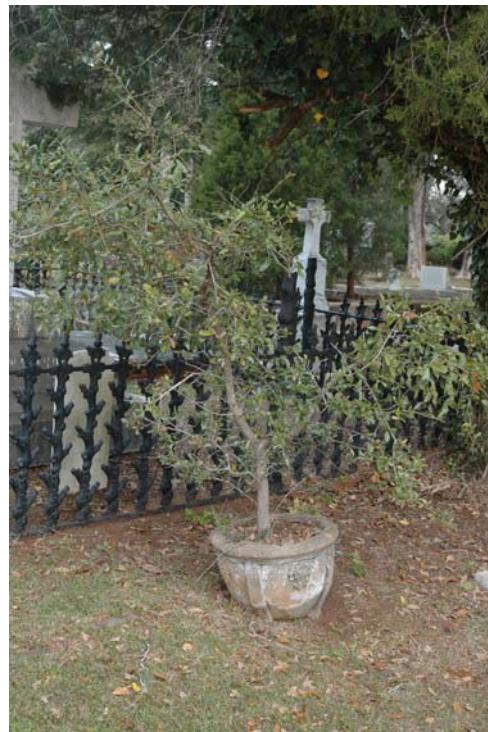
Figure 28. Tree problems at Memory Hill. The top photograph illustrates incorrect planting of Leyland cypress. These trees have a spread of up to 25 feet and a height of up to 50, yet they have been planted in an area where their growth is stunted and will cause future problems. The lower two photographs show volunteer growth that is being ignored by current landscape practices. Left unrestrained these plants will cause significant long-term damage.

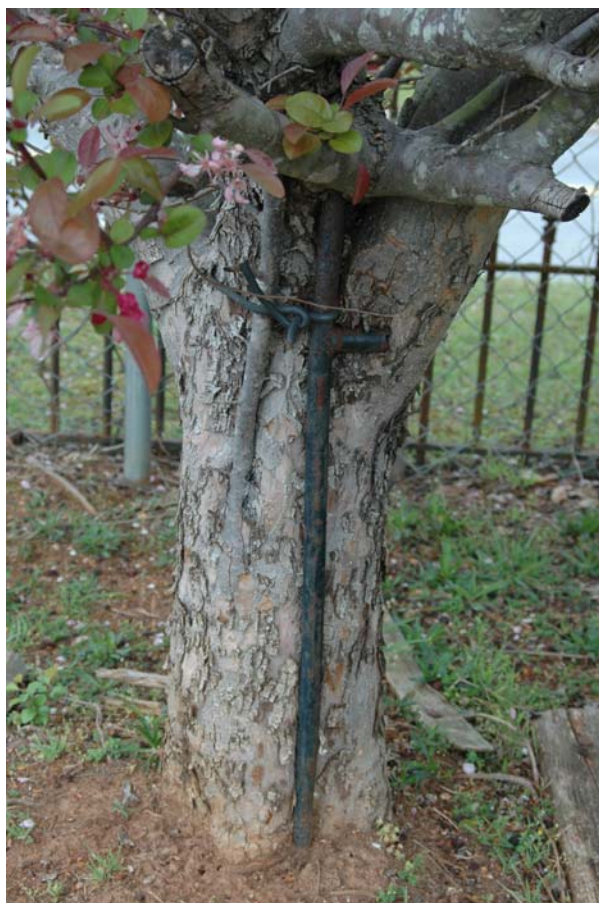
Figure 29. Tree that was planted, inappropriately staked, and then forgotten.

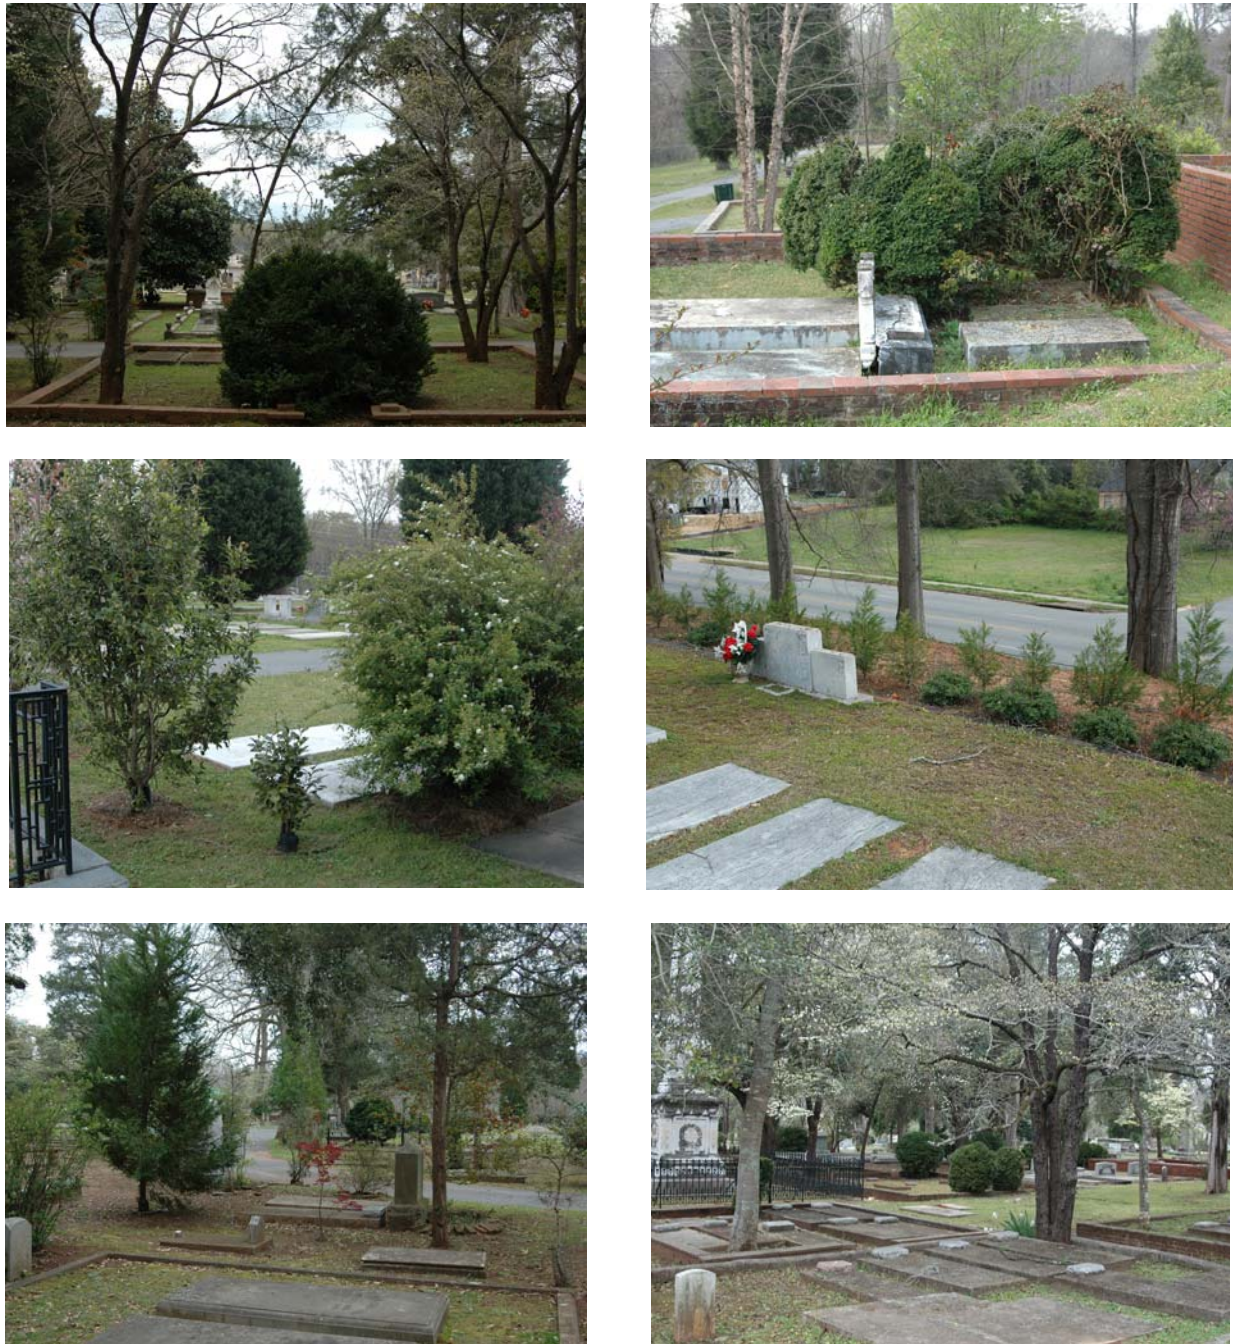
Figure 30. Examples of shrubbery problems at Memory Hill. The top left photograph shows a boxwood planted at the entrance to a plot, hindering access. The top right photograph illustrates poorly maintained plantings taking over the plot. The middle left photograph shows planting that, in time, will create a screen, reducing security and providing hiding places. The middle right photograph shows plantings placed too close together. The bottom photographs illustrate the densely planted and cluttered landscape in Memory Hill.

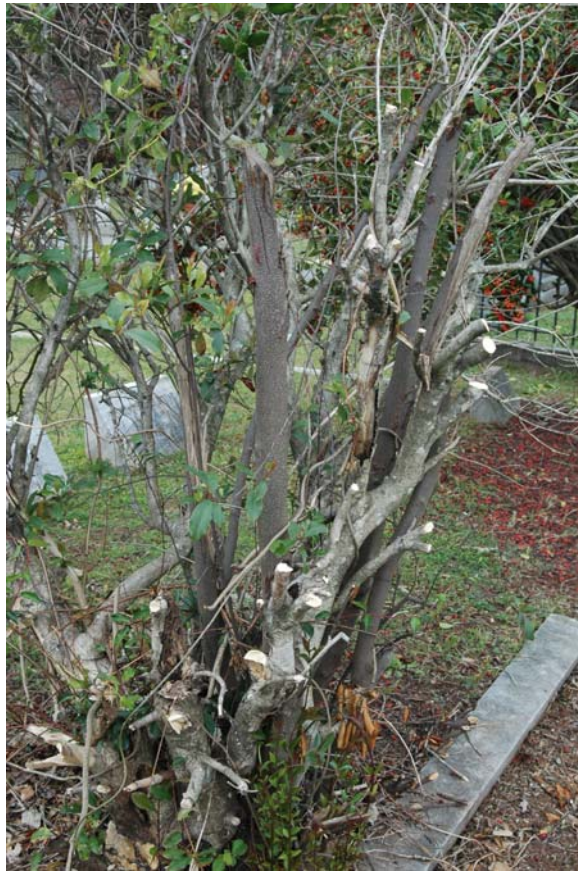
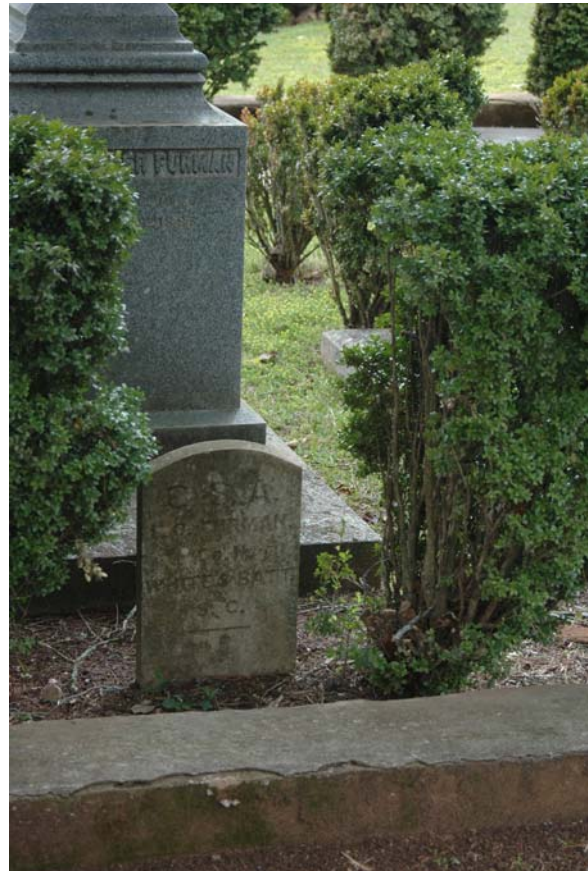
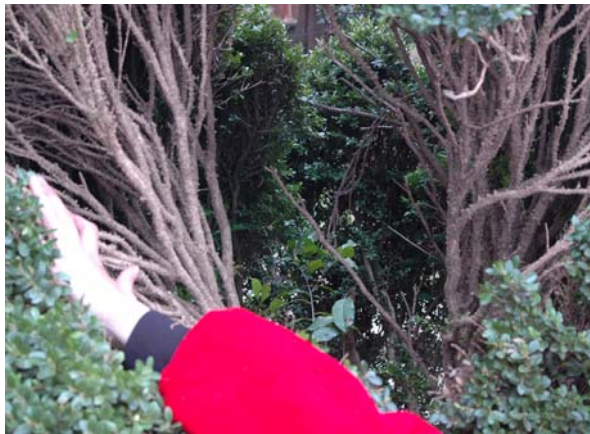
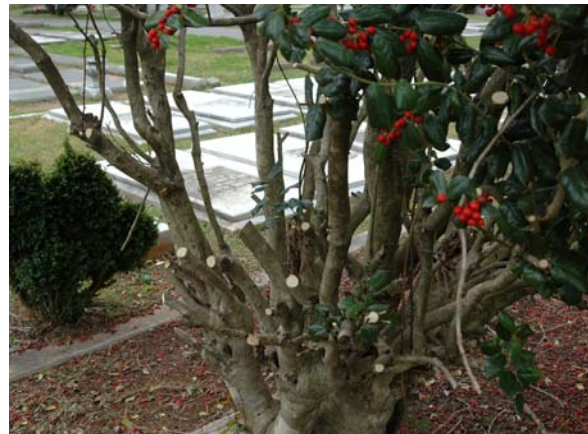
Figure 31. Shrubbery problems at Memory Hill. The upper left and lower right photographs illustrate incorrectly pruned shrubs. The upper right photograph illustrates incorrect pruning of boxwood to avoid a stone. The lower left photograph illustrates dead wood inside an inappropriately sheared boxwood.

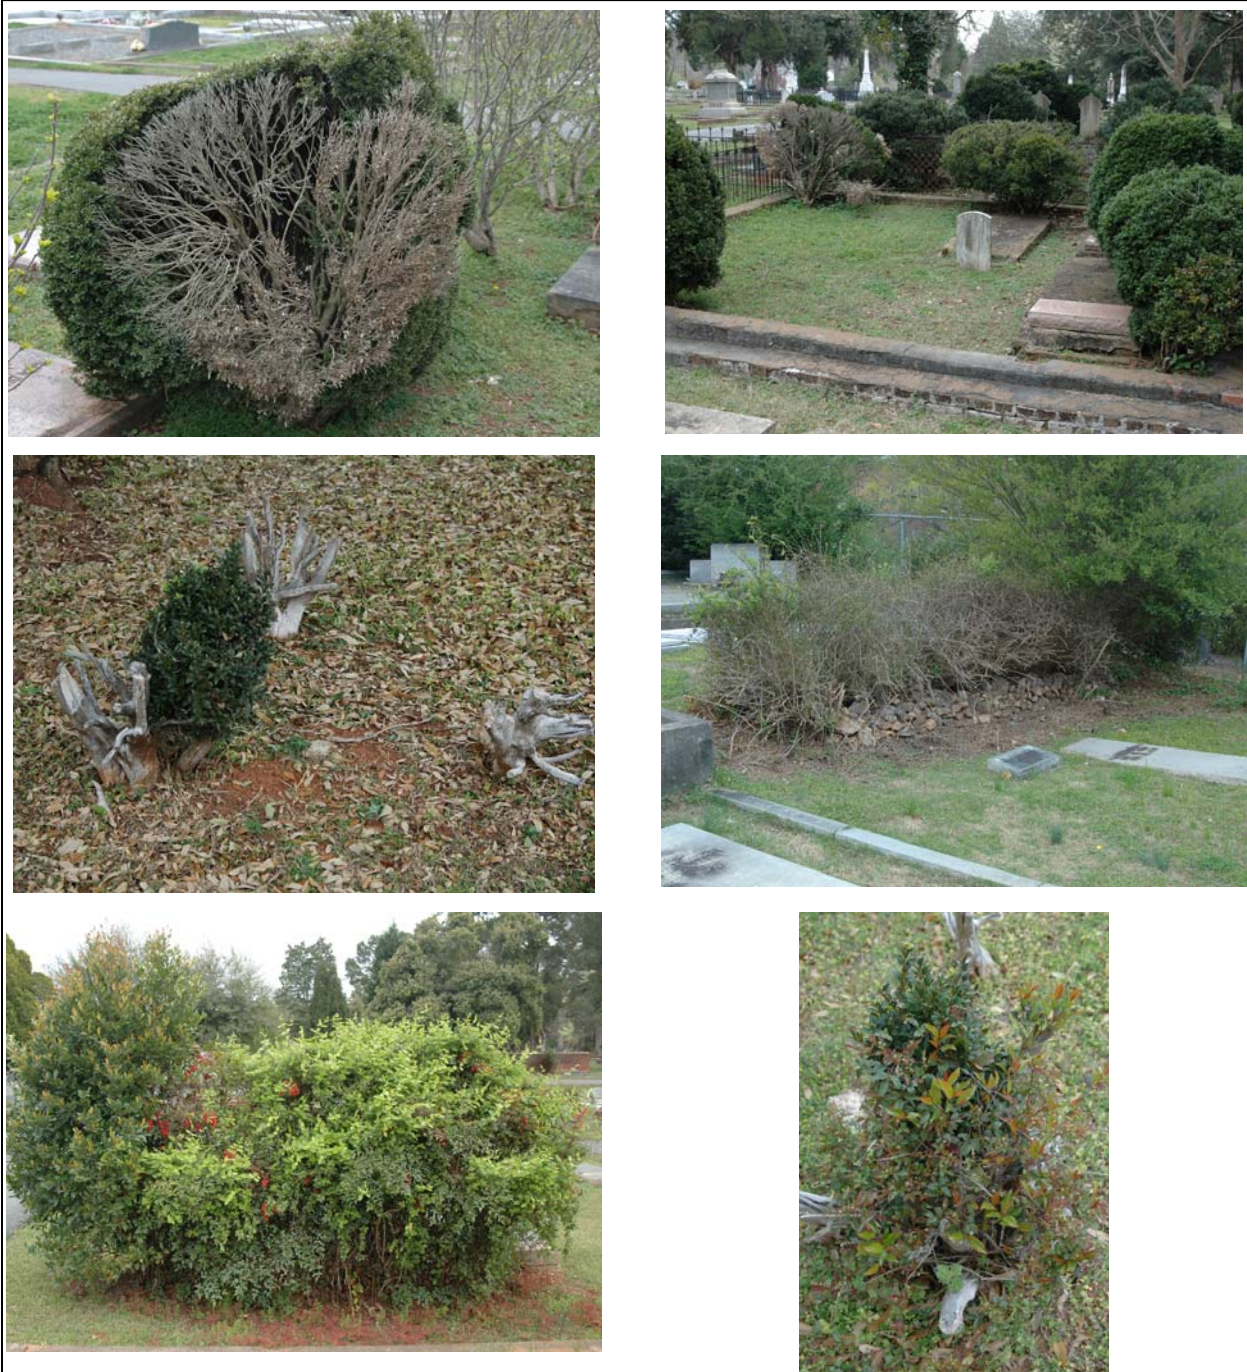
Figure 32. Shrubby problems at Memory Hill include dead boxwoods, shrubs so heavily pruned that they have been killed, shrubs that require pruning and rehabilitation, and shrubs that are overgrown with weedy species, indicating a lack of care.

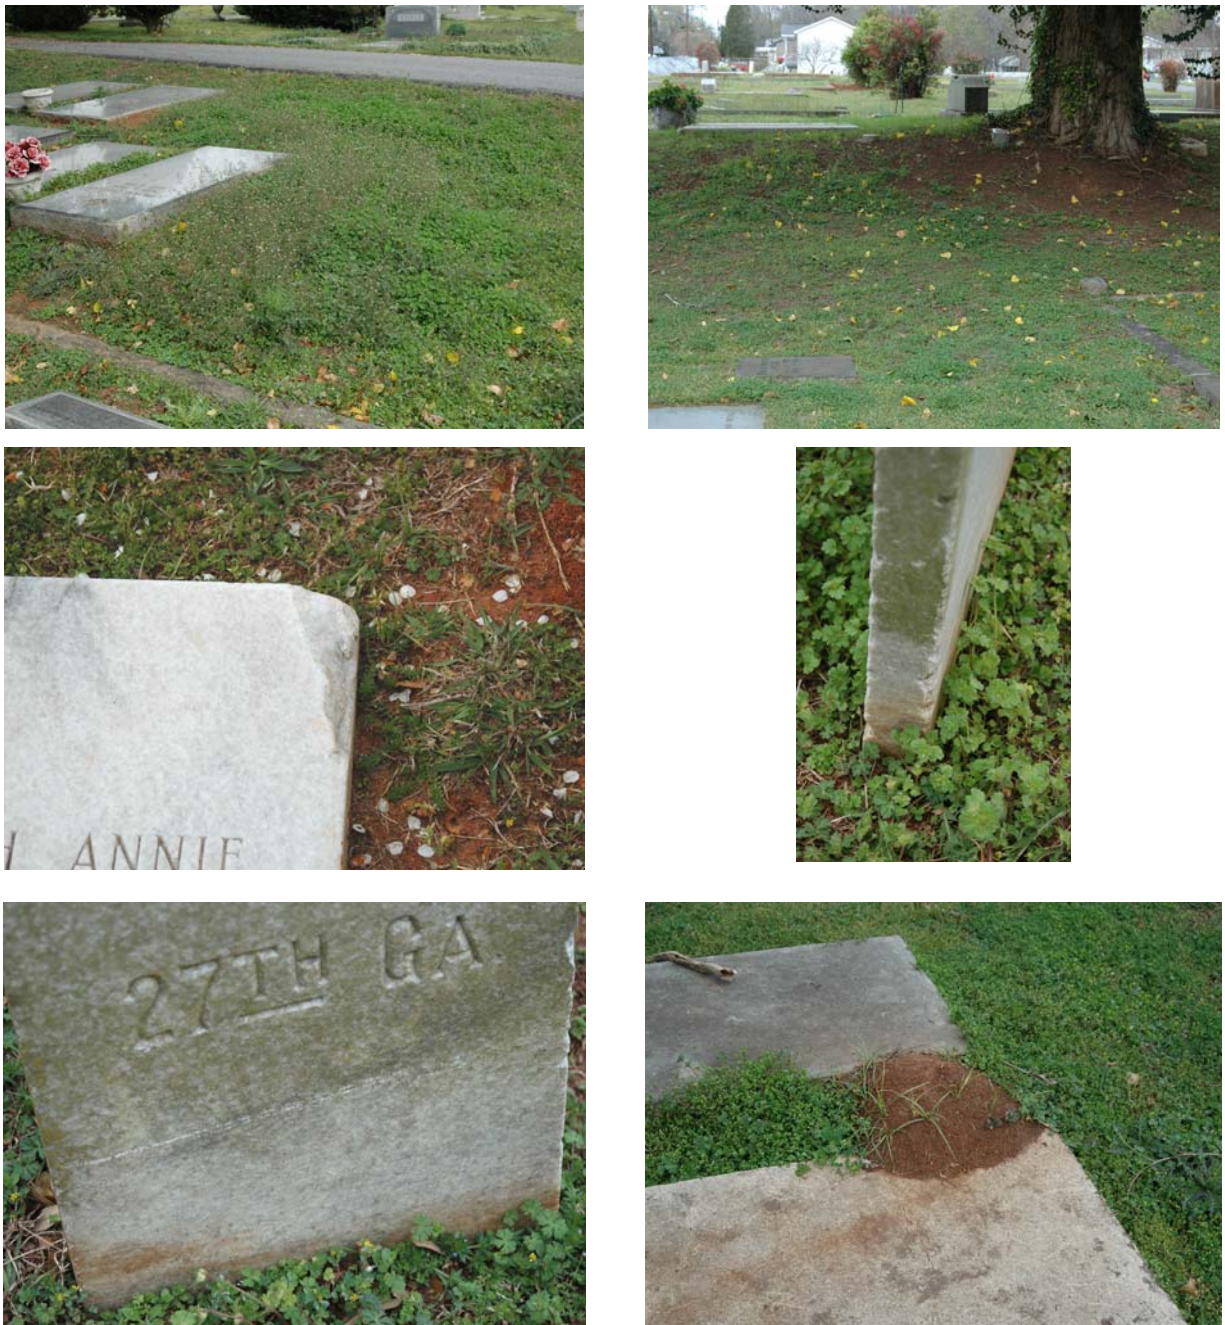
Figure 34. Typical lawn problems at Memory Hill. The upper left photograph illustrates heavy broad leaf weeds. The upper right photograph illustrates sparse grass on a terrace. The middle left photograph illustrates mower damage – caused by operating the mower over the stone. The middle right photograph illustrates impact damage caused by a mower. The lower left photograph illustrates nylon trimmer abrasion of a stone. The lower right photograph illustrates a major fire ant nest – these are common in the cemetery and pose a significant hazard.

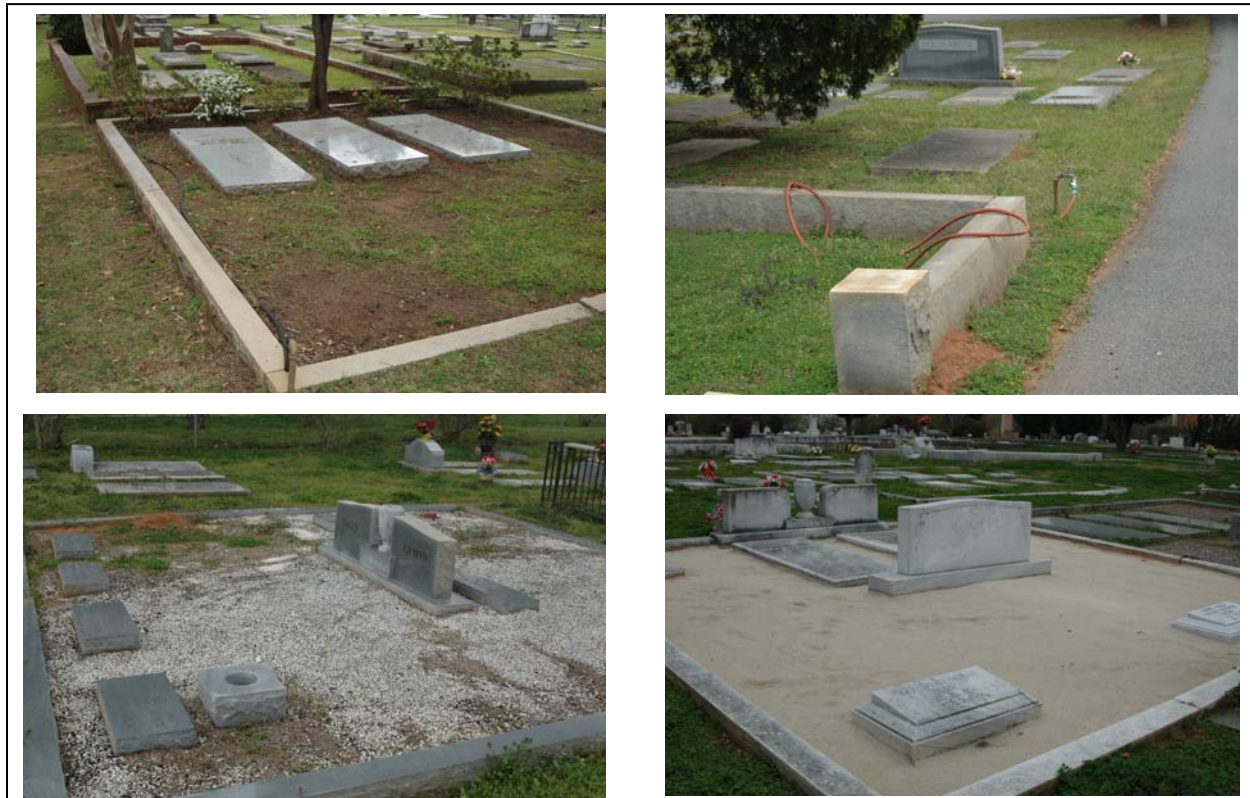
Figure 35. Other landscape problems. The top photographs show the appropriation of hose bibs for individual lots. This practice is costly to the City, denies access to others, and causes maintenance problems. Consequently, all such hoses should be immediately removed from the cemetery. The bottom photographs illustrate several “alternative” plot treatments that are historically inappropriate and that detract from the historical integrity of the cemetery. Graveled and sanded plots also do not stop weeds and require maintenance that is typically not provided.

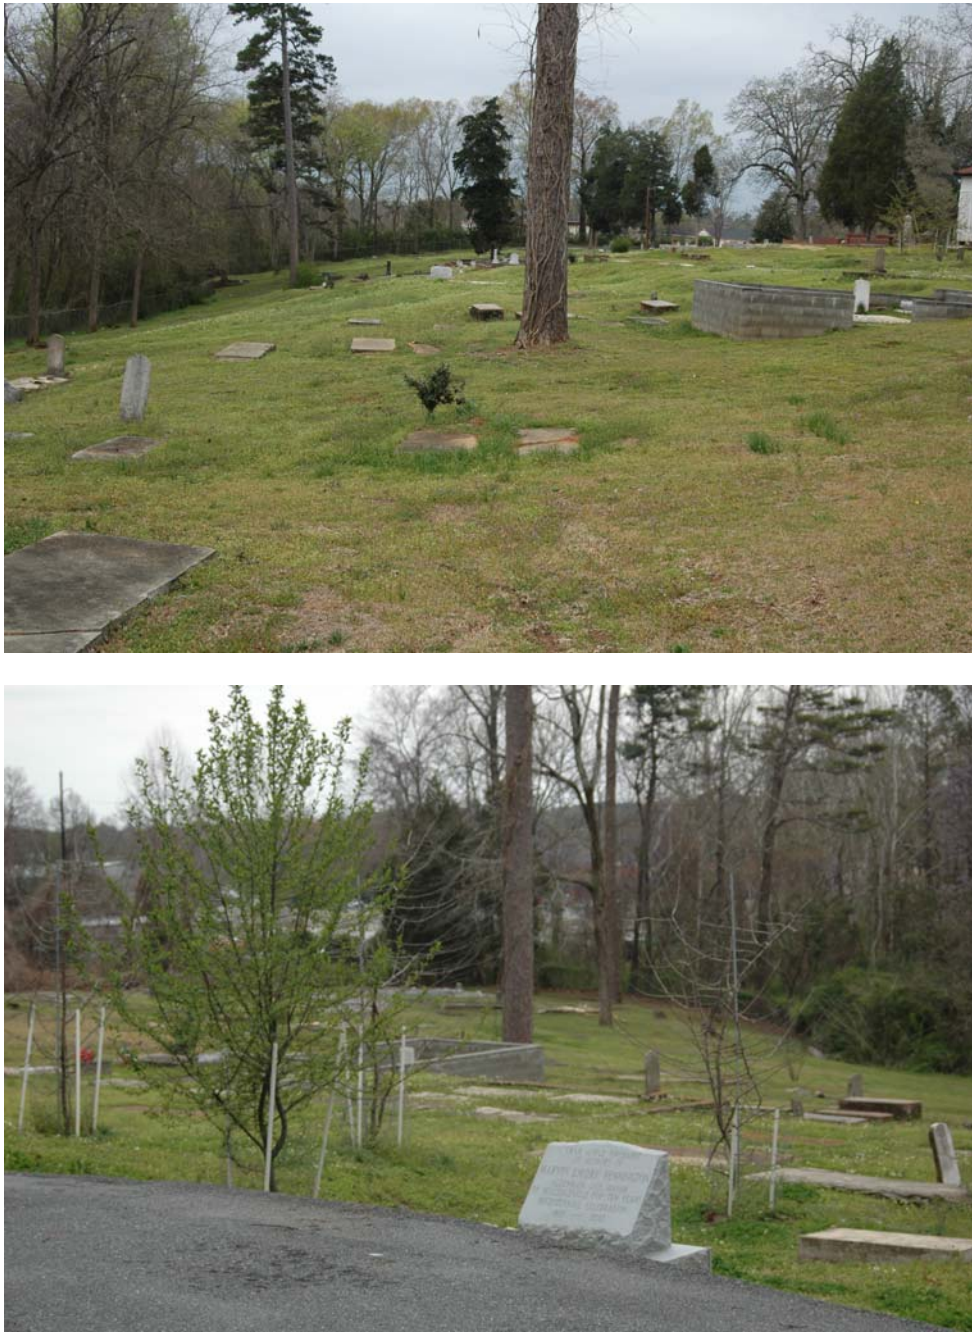
Figure 36. Landscape issues associated with the African American section of Memory Hill. The upper photograph reveals the bleak appearance of the African American section, which stands in stark contrast to the over-landscaped predominately white section. Efforts should be undertaken to improve the African American section using appropriate plantings. The lower photograph shows a private memorial that the City allowed, inappropriately, to be erected on the African American cemetery. This memorial should be removed.

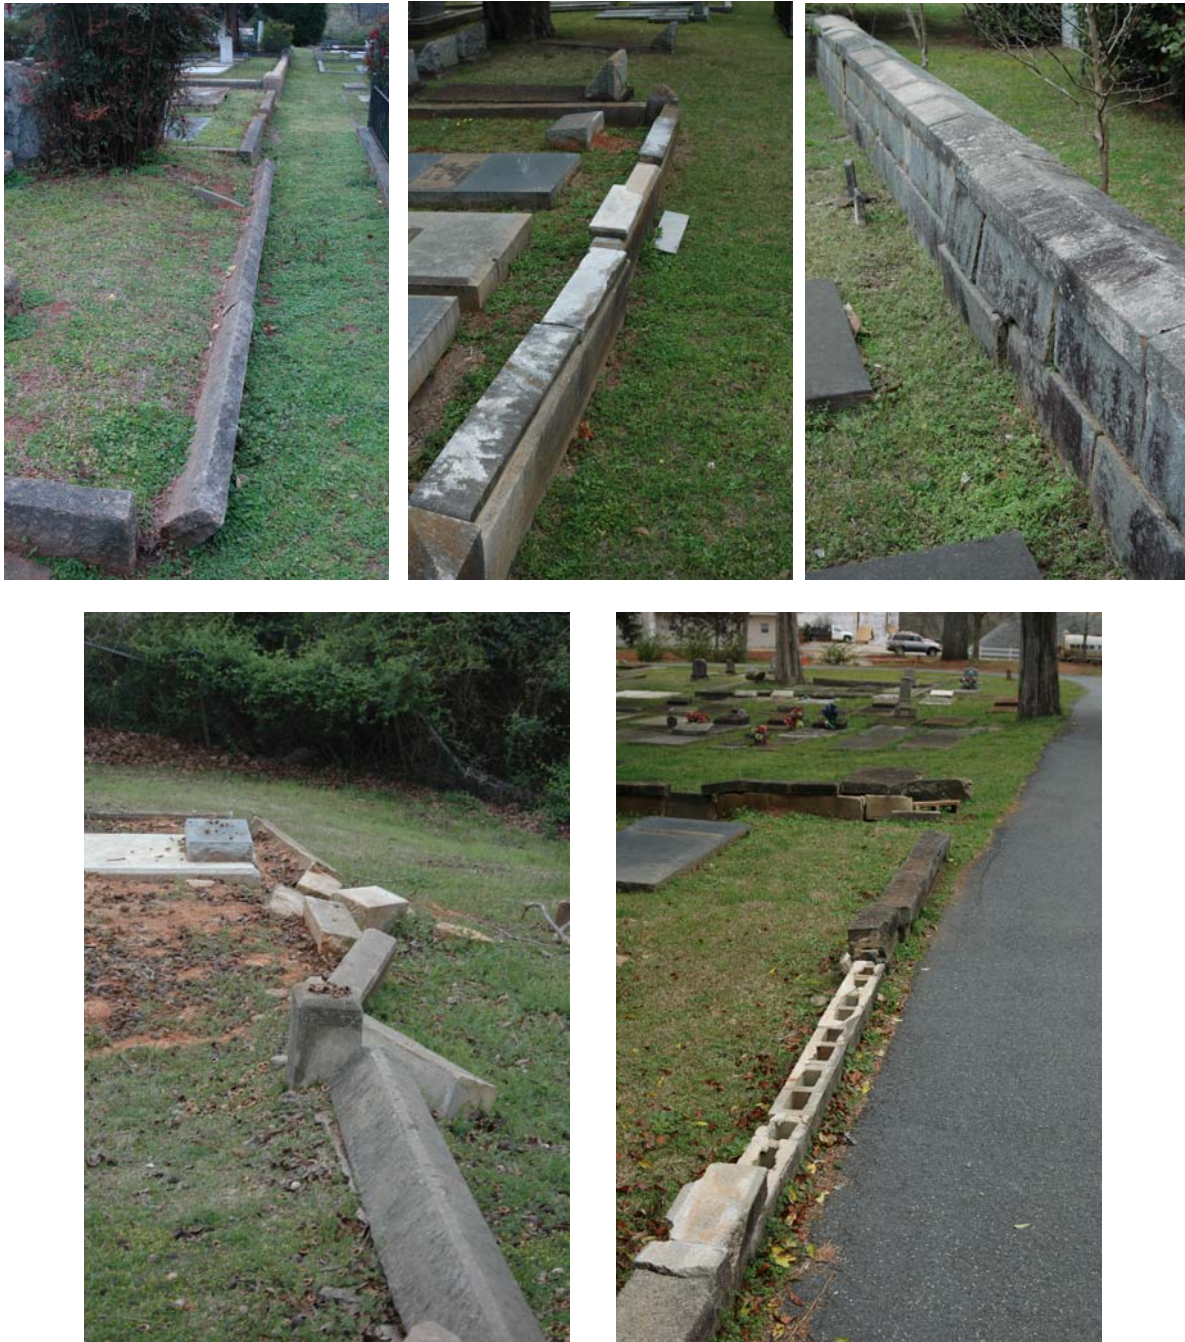
Figure 37. Damaged plot copings. These photographs document the extent of damaged coping and plot walls throughout the cemetery. In some cases repair is fairly simple and will involve simply resetting the existing coping, perhaps with a better foundation, or perhaps reattaching loose elements using an appropriate high-lime mortar. In other cases the damage is so severe that the wall will need to be rebuilt.

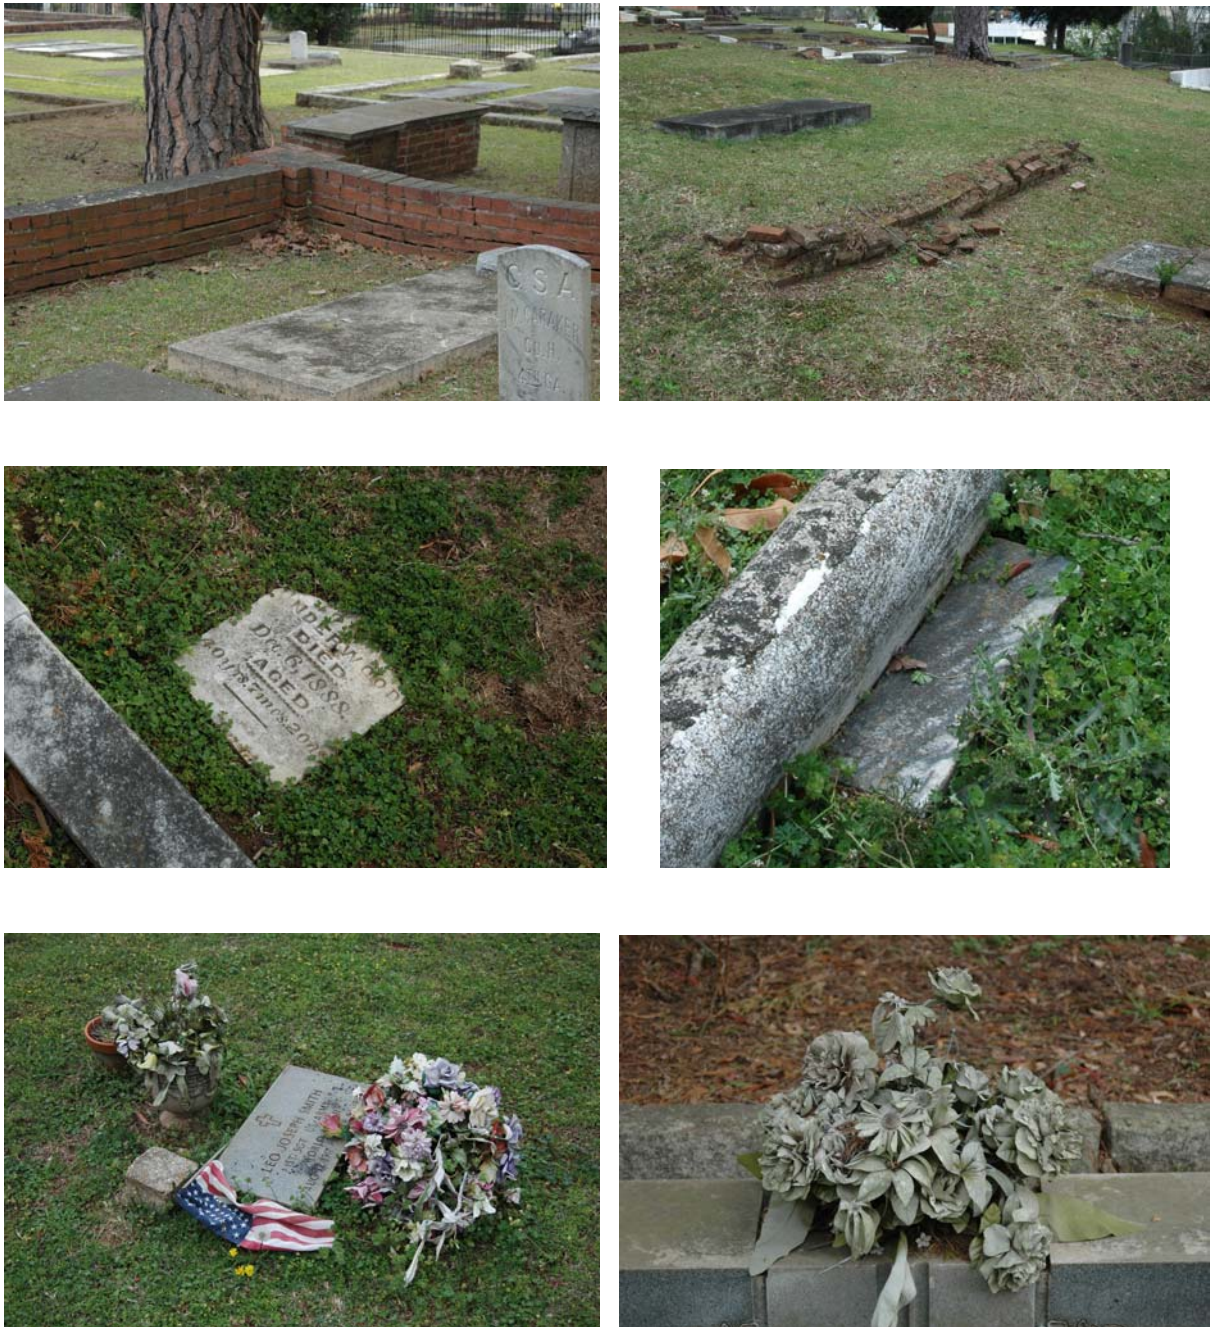
Figure 38. Maintenance problems. The upper photographs examples of damaged or failed brick walls that require immediate intervention. The middle two photographs provide examples of displaced or “lost” stones in the cemetery that require collection and safe storage. The bottom two photographs show faded grave decorations that require removal by the City. We recommend that arrangements be removed every two weeks.

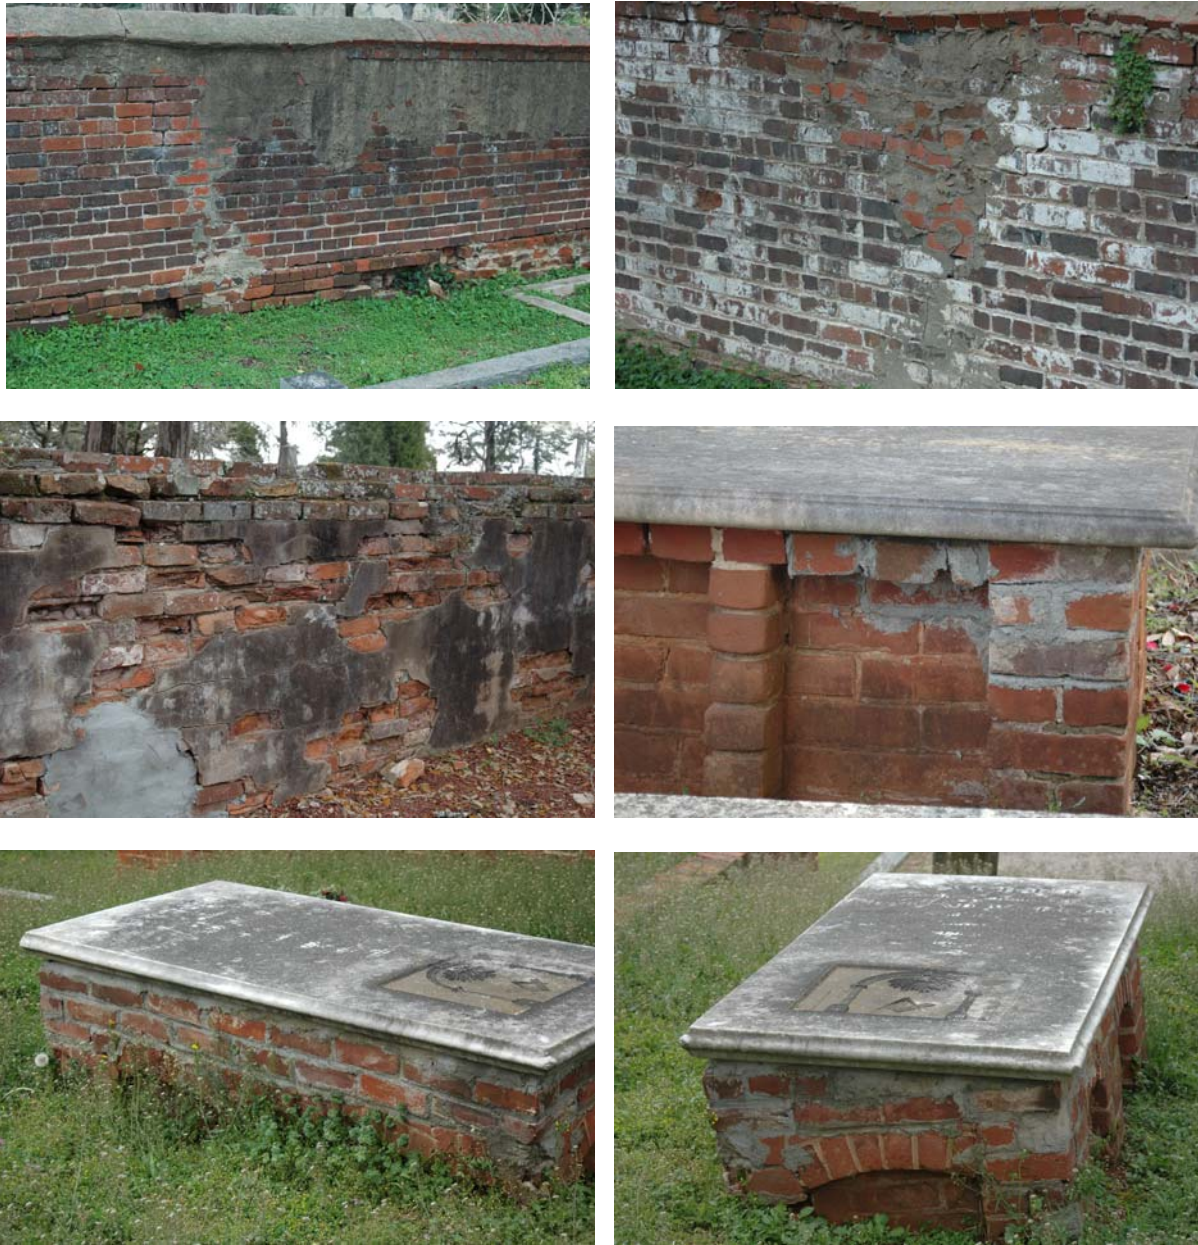
Figure 39. Examples of inappropriate masonry repairs. The upper left photograph shows hard Portland cement smeared on the outside of a plot wall, thickened joints, and mismatched replacement bricks. The upper right photograph illustrates excessive use of hard Portland cement mortar, no effort to align bricks, and no effort to finish the joints. The left middle photograph illustrates inappropriate use (and failure) of a hard Portland cement stucco and damage that has been done to the soft bricks. The right middle photograph shows a poor box tomb repair, again using hard Portland cement mortar, no joint finish, and no effort to clean up the brick afterwards. The bottom two photographs show a box tomb where the ledger has been "leveled" by simply building up an excessive amount of Portland cement. Instead, the tomb should have been jacked level and the foundation problem corrected.

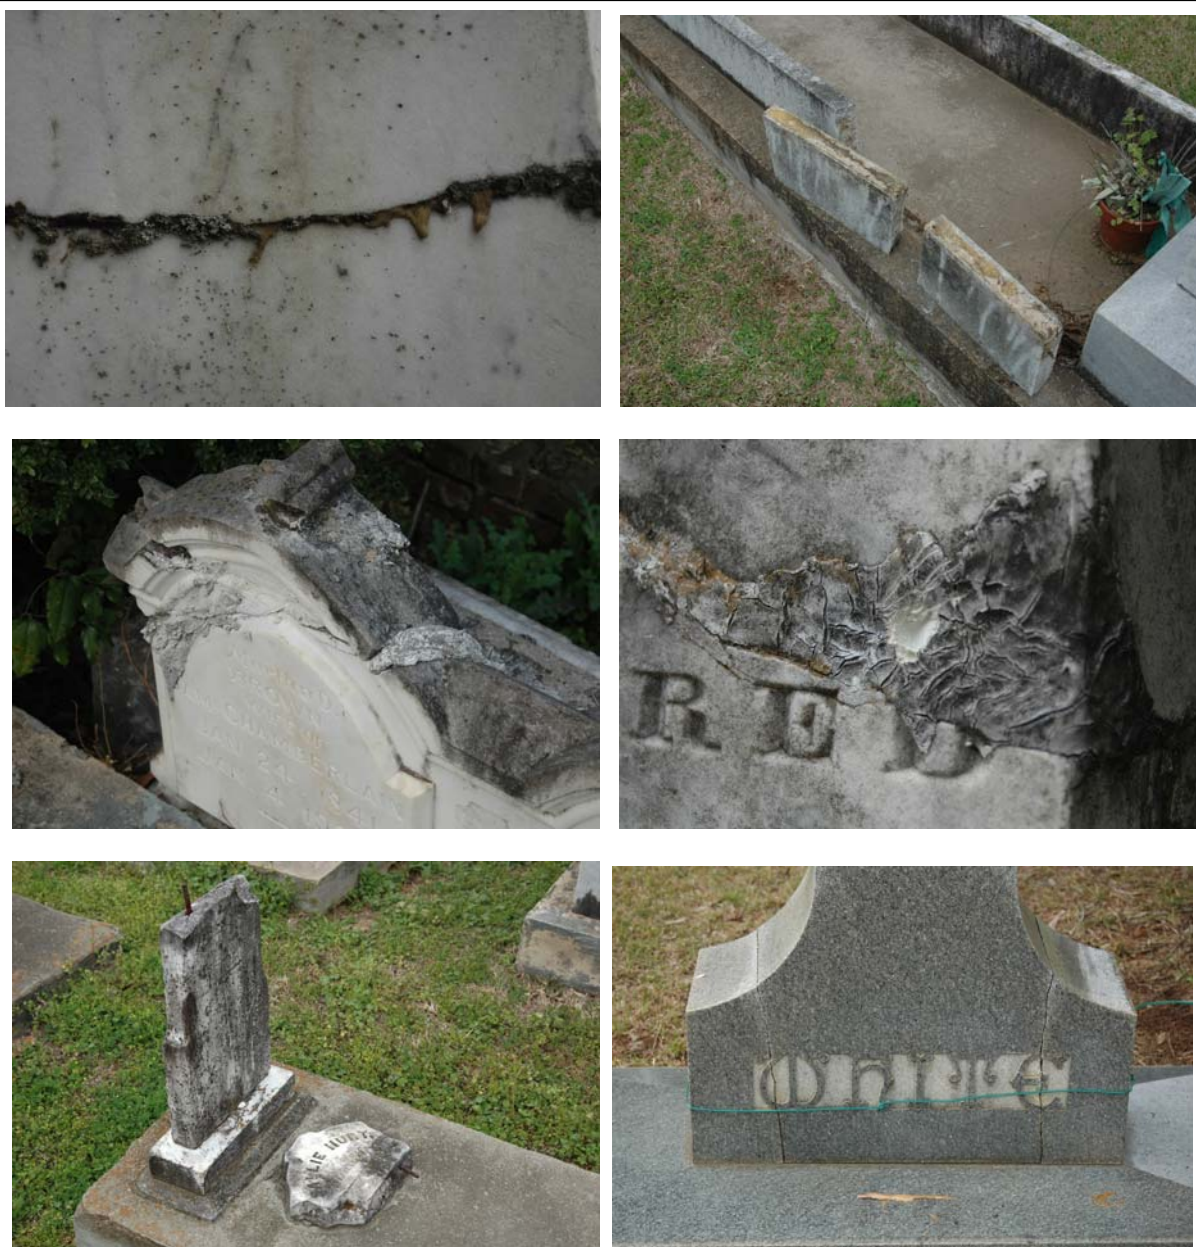
Figure 40. Poor repairs. The upper left photograph shows poor workmanship using epoxy. The upper right photograph shows the use of an inappropriate adhesive, probably Liquid Nails™. The middle left photograph shows poor use of a white Portland cement that has defaced a monument. The middle right photograph shows an inappropriate fill material, possibly a window putty. The lower left photograph illustrates a failed repair that used ferrous pins. In addition, the top portion of the stone has been cemented to the ledger, making a future repair almost impossible. The lower right photograph shows a badly damaged granite marker being held together with poly-coated wire.

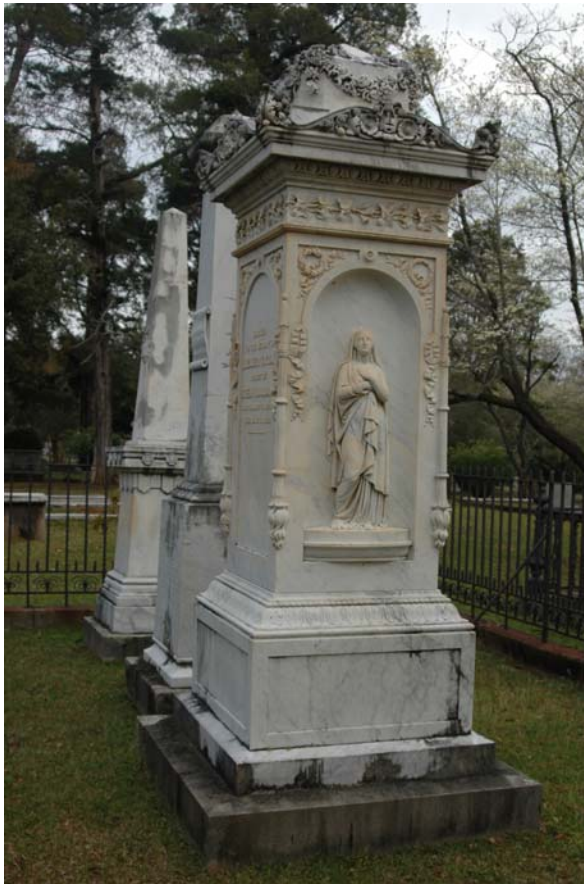
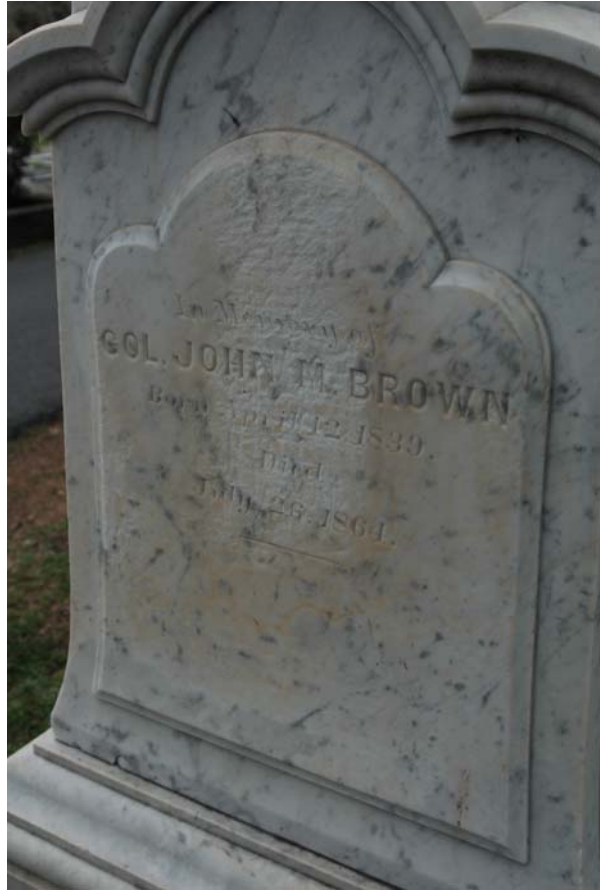
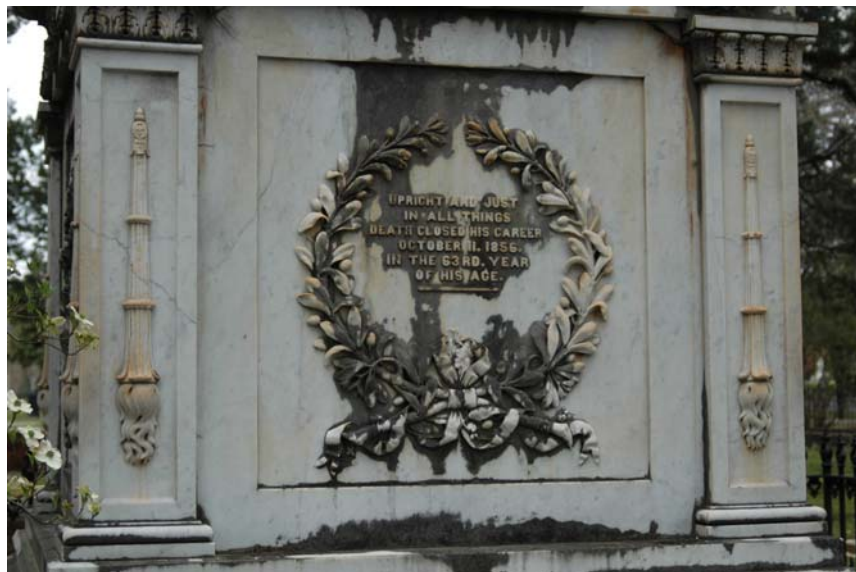
Figure 41. Inappropriate cleaning at Memory Hill. The yellow staining and erosion (seen clearly in the upper right photograph) are all the result of bleach applications.
